Carrier 19C 1200 ton Centrifugal Chiller Repair Case Study

Class "A" High Rise

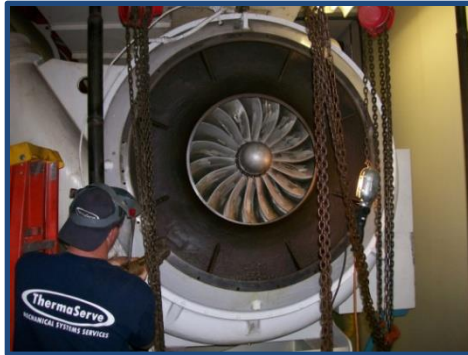
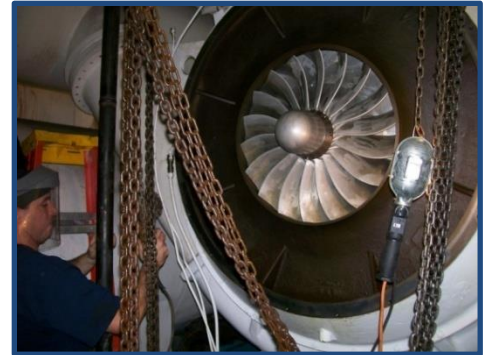
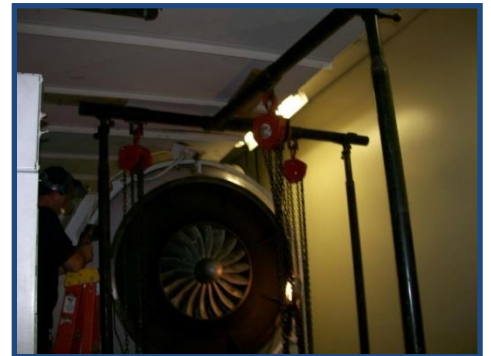
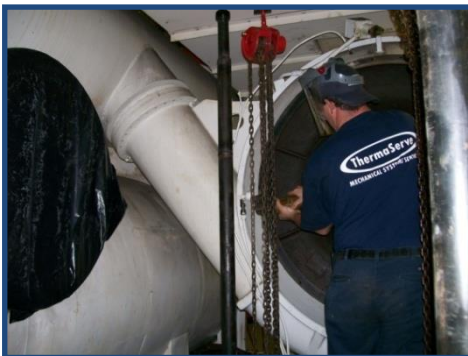
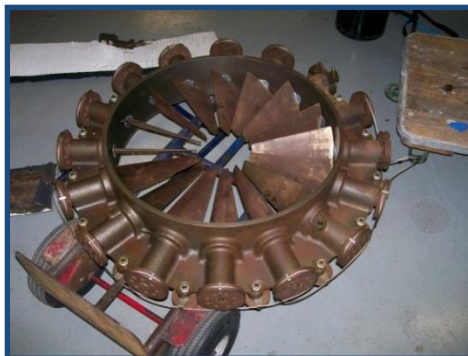
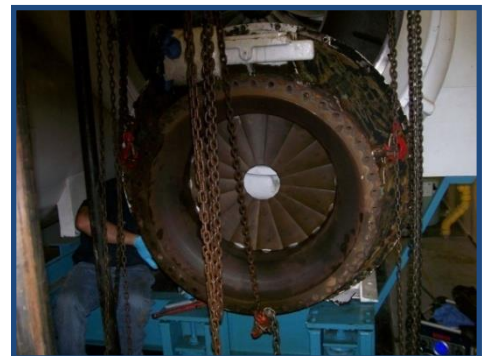
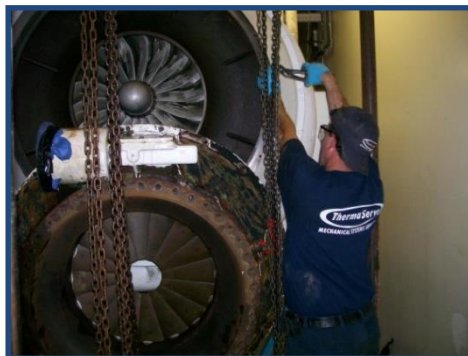
Inlet guide vanes were seized

No room for rigging and had to custom build a gantry to rig

Machines have to be repaired in place because they are located on the 36th floor
