Carrier 19EB Centrifugal Chiller Repair Case Study

Class "A" High Rise

Eight Year Stop Major –
mechanical inspection

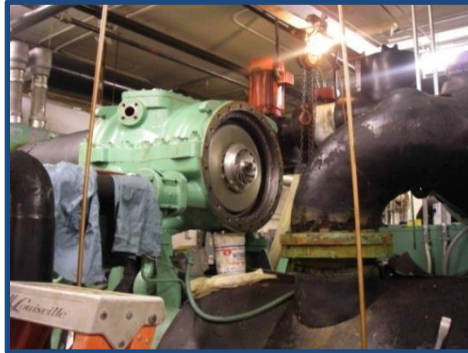
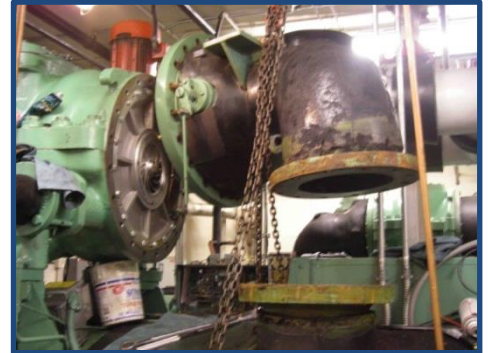
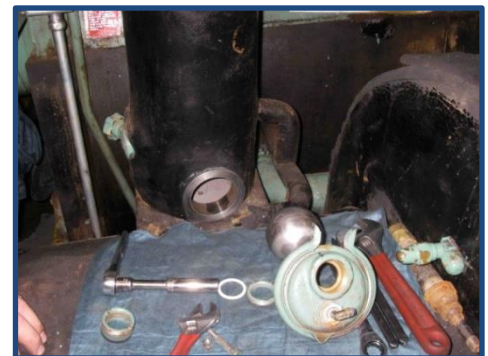
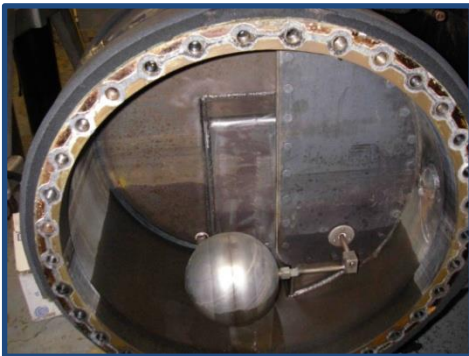
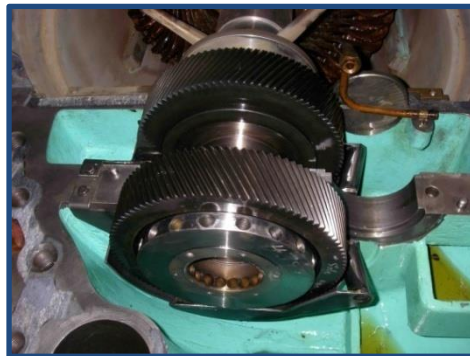
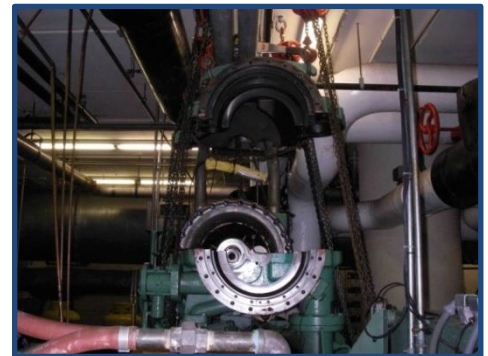
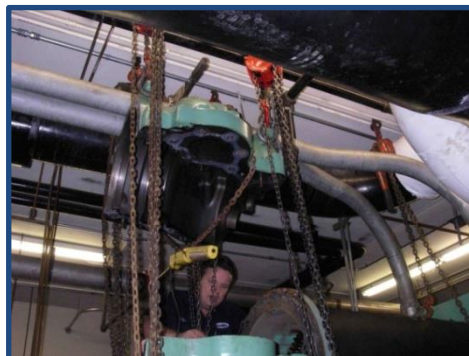
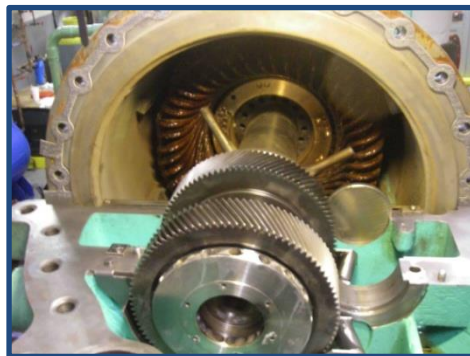
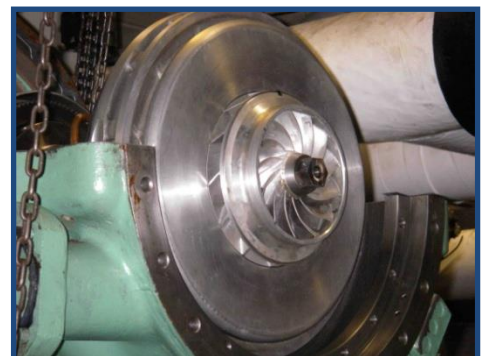
Detected bearing wear and therefore able to replace during inspection.
