Trane CVHF 1500 ton Centrifugal Chiller Compressor Lift Case Study

Municipal Chiller plant serving a major hospital

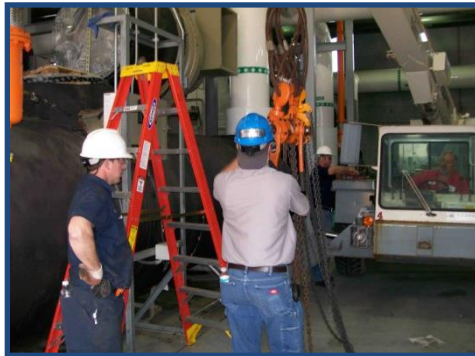
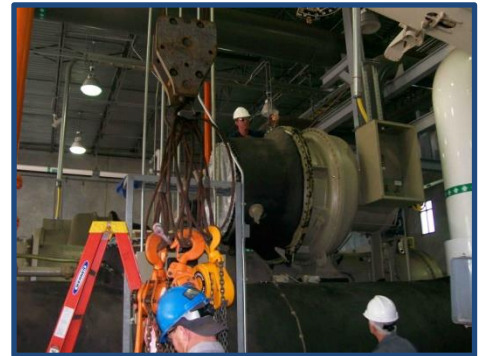
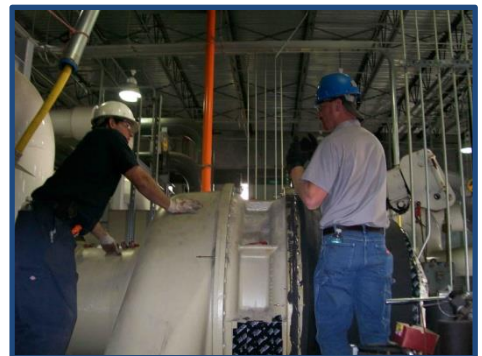
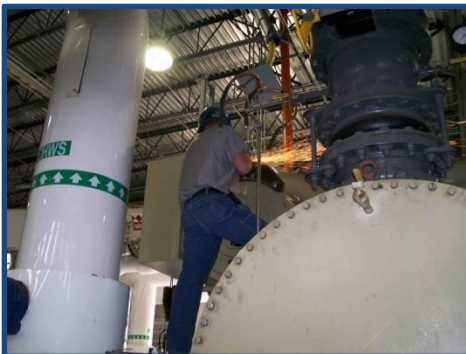
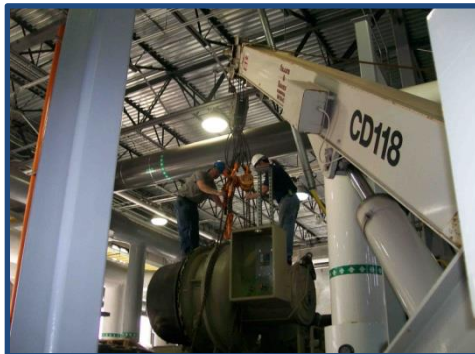
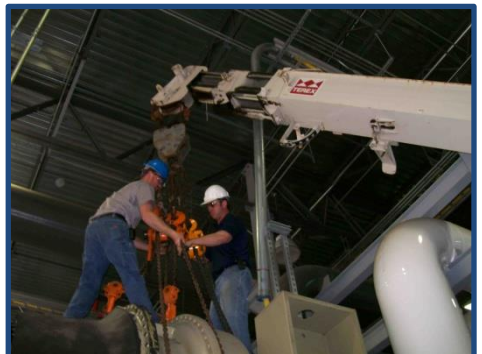
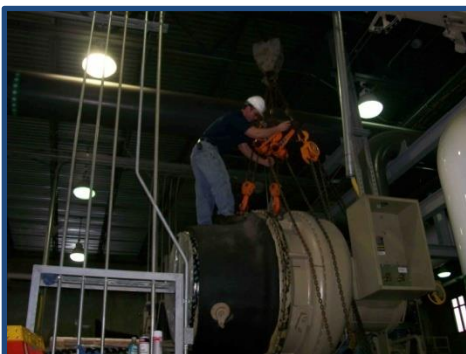
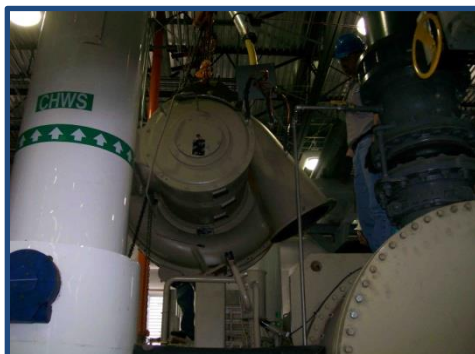
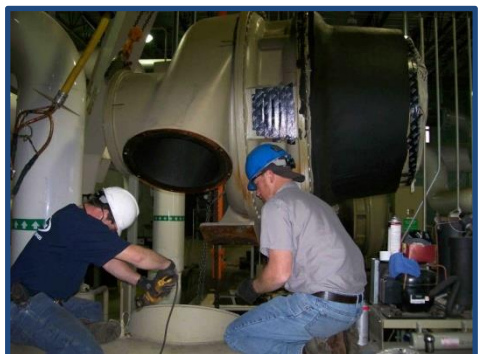
Leaking discharge O ring needed replacement

14,000lbs compressor lift

Used a crane with inches to spare in overhead space

Normal procedure would be to breakdown the compressor to get to the O ring, however, this procedure represented half the normal repair time at half the cost.
