Underground Piping Repair Case Study

Mechanical Systems Services

Resort Condominium

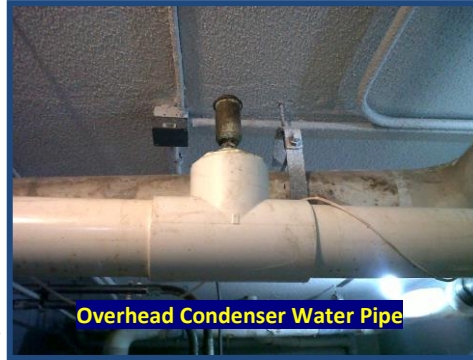
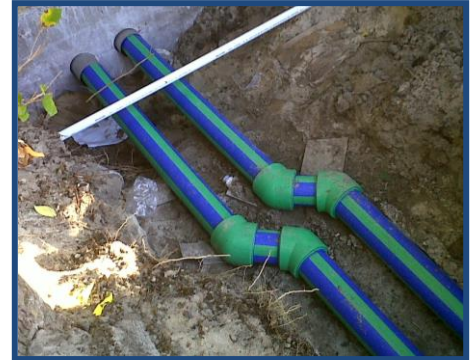
The Cooling Tower was originally installed lower than the piping in The Mechanical room causing the pump to lose prime when the chiller shutdown. We relocated the condenser pump, installing the piping lower than the tower solving the problem.

New Aquatherm Greenpipe® polypropylene pressure piping system was installed, with heat welded connections and joints used as a superior long term cost effective solution.

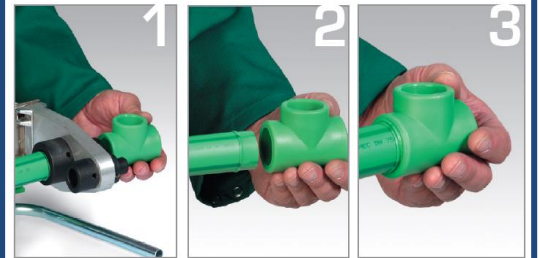
There's no better way to join pipe and fittings together than physically turning them into one piece.

There are no glues, gaskets or solders: a fused connection is identical all the way through.
