Underground Piping Repair Case Study

Mechanical Systems Services

Resort Condominium

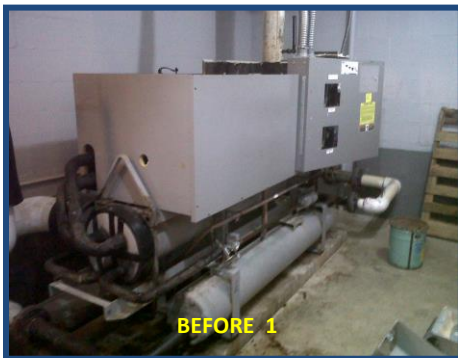
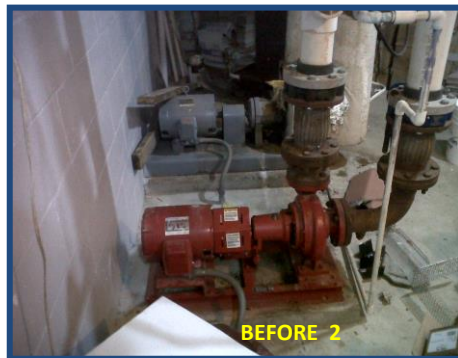
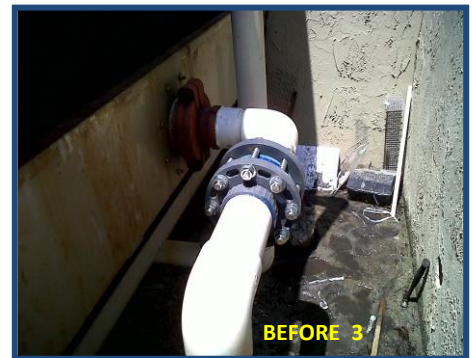
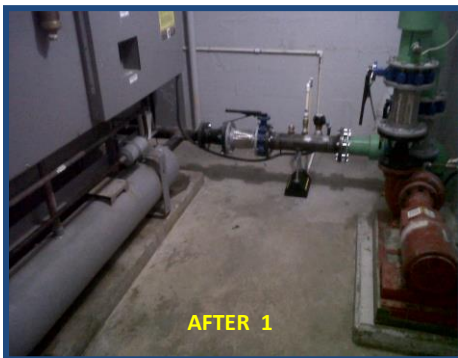
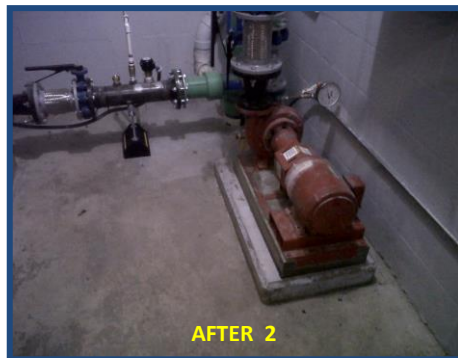
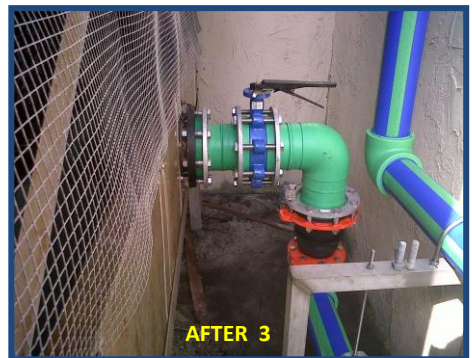
Replace broken underground schedule 40 PVC piping.

The Cooling Tower was originally installed lower than the piping in The Mechanical room causing the pump to lose prime when the chiller shutdown. We relocated the condenser pump, installing the piping lower than the tower solving the problem.

New Aquatherm Greenpipe® polypropylene pressure piping system was installed, with heat welded connections and joints used as a superior long term cost effective solution.
